CRS No. A-00008

Address: 192 Bowers Beach Road

Name: Robert and Amelia Warren Property

CULTURAL RESOURCE SURVEY
PROPERTY IDENTIFICATION FORM

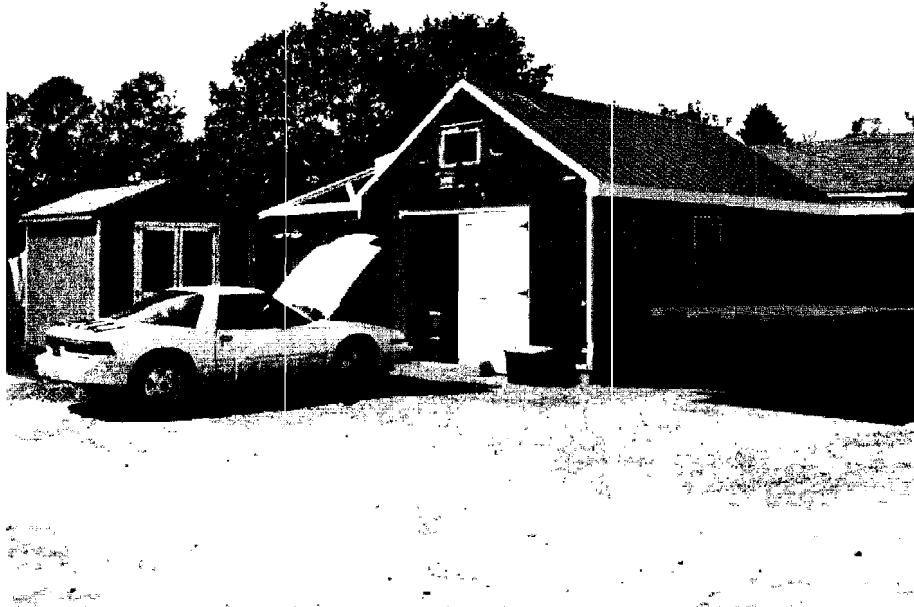
South of the dwelling rests a one-and-one-half-story shed. The shed rests on a concrete block foundation, and the exterior walls are clad with asbestos shingles. The front gable roof is sheathed in standing seam metal. A shed roof that extends from the west elevation is also sheathed in standing seam metal and shelters a dog pen enclosed by chain-link fencing. Paired plank wood doors provide access to the interior in the south elevation, and double-hung sash wood windows light the east, west, and north elevations. A modern, prefabricated shed is located adjacent to the southwest corner of the shed.

A-00008. Photograph 3: Shed, south and east elevations, looking northwest. This shed was constructed ca. 1950. Note the modern, prefabricated shed on the left side of the photograph.

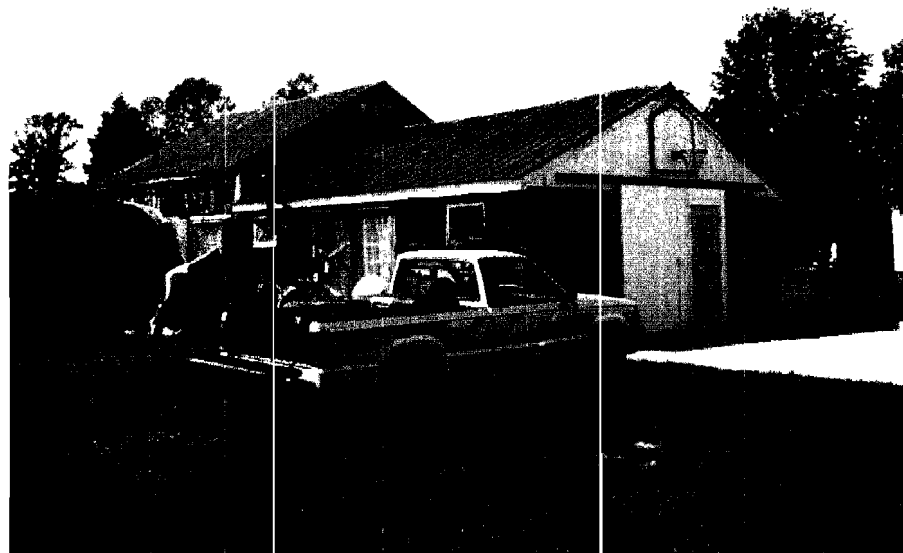
A-00008. Photograph 4: Garage/workshop, south and east elevations, looking northwest. Note the greenhouse that extends from the south elevation of the barn.

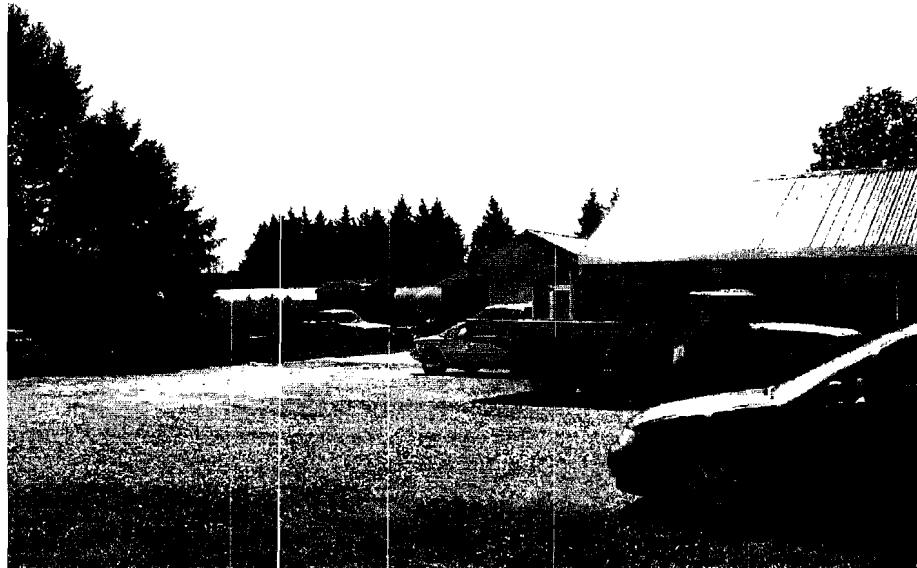
A-00008. Photograph 7: Overview of the outbuildings, looking southwest.
